Manhole Inspection Summary

Manhole # S39A1_002MH

Insp Date: **12/8/08 1:11 PM**

Location Address: **e cromwell st**

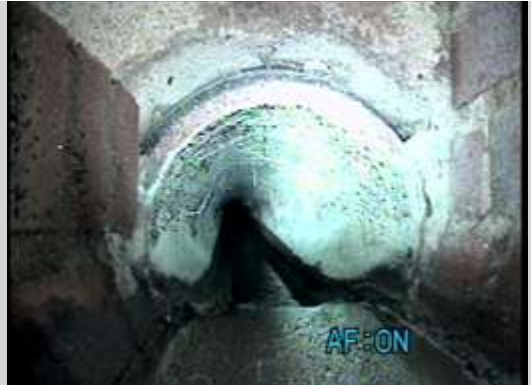
12 O'Clock Outflow

8 in. Circular Gravity Sewer
Pipe Out @ 12 O'Clock

Pipe Material: **Clay** ☐ Pipe Lined

Invert Depth: 12.00 (ft.) Flow Characteristics: **Slow**

Deposits: ☒ None ☐ Mud ☐ Sludge ☐ Debris ☐ Grease

Infiltration: **None** Pipe Seal Cond: **Unknown**

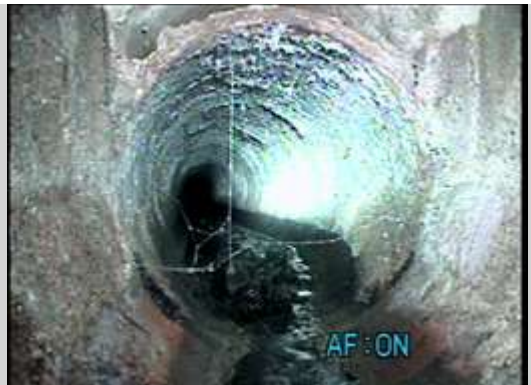
3 O'Clock Inflow

8 in. Circular Gravity Sewer
Pipe In @ 3 O'Clock

Pipe Material: **Clay** ☐ Pipe Lined

Invert Depth: 11.33 (ft.) Flow Characteristics: **None**

Deposits: ☒ None ☐ Mud ☐ Sludge ☐ Debris ☐ Grease

Infiltration: **None** Pipe Seal Cond: **Unknown**

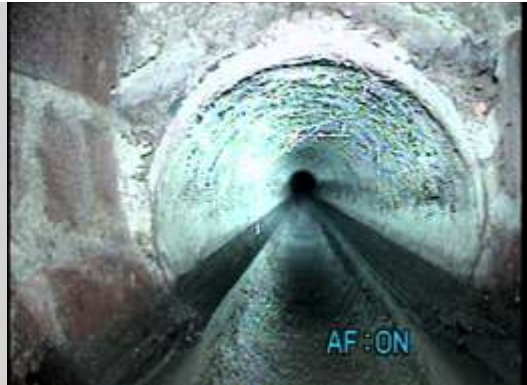
6 O'Clock Inflow

8 in. Circular Gravity Sewer
Pipe In @ 6 O'Clock

Pipe Material: **Clay** ☐ Pipe Lined

Invert Depth: **11.75** (ft.) Flow Characteristics: **Slow**

Deposits: ☒ None ☐ Mud ☐ Sludge ☐ Debris ☐ Grease

Infiltration: **None** Pipe Seal Cond: **Unknown**
